**DEPARTMENT OF TRANSPORTATION**

Quality Assurance and Source Inspection

Contract #: 04-0120F4Cty: SF/ALA Rte: 80 PM: 13.2/13.9File #: 69.28**WELDING INSPECTION REPORT****Resident Engineer:**Pursell, Gary**Address:** 333 Burma Road**City:** Oakland, CA 94607**Report No:** WIR-016498**Date Inspected:** 19-Aug-2010**Project Name:** SAS Superstructure**OSM Arrival Time:** 700**Prime Contractor:** American Bridge/Fluor Enterprises, a JV**OSM Departure Time:** 1900**Contractor:** Zhenhua Port Machinery Company, Ltd (ZPMC), Changxing Island **Location:** Shanghai, China**CWI Name:** Mr.Qiu Wen**CWI Present:** Yes No**Inspected CWI report:** Yes No N/A**Rod Oven in Use:** Yes No N/A**Electrode to specification:** Yes No N/A**Weld Procedures Followed:** Yes No N/A**Qualified Welders:** Yes No N/A**Verified Joint Fit-up:** Yes No N/A**Approved Drawings:** Yes No N/A**Approved WPS:** Yes No N/A**Delayed / Cancelled:** Yes No N/A**Bridge No:** 34-0006**Component:** Tower and Orthotropic Box Girder (OBG)**Summary of Items Observed:**

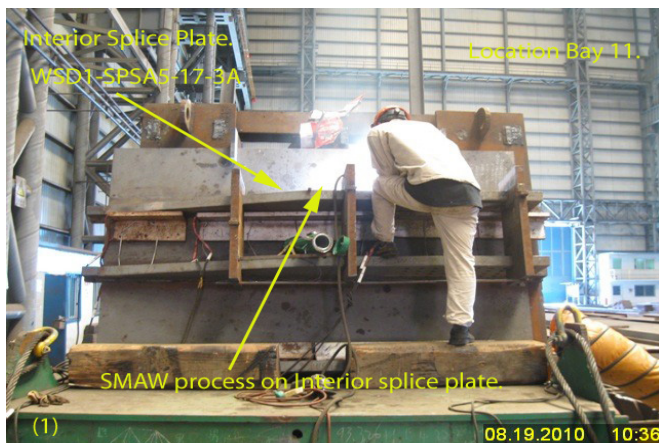
This QA Inspector observed ZPMC qualified welding personnel identified as 202100, Perform Shielded Metal Arc Welding (SMAW) on Interior splice plate, Joint identified as WSD1-SPSA5-17-3A. ZPMC QC Identified as Liu Dao Feng. The welding parameters as measured using QC's calibrated instrument appeared to be in general compliance with WPS-B-T-3211-Tc-U5b-1. For more information see below attached picture number 1.

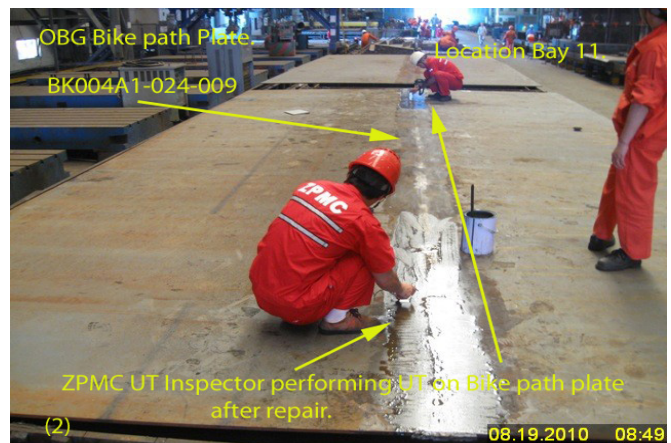
This QA Inspector observed ZPMC Ultrasonic Testing Inspector, performing UT on OBG Bike path plate after repair at 31 Location. Joint identified as BK004A1-024-009. For more information see below attached picture number 2.
